Corridor Review and Prioritization

Prepared for Fayette Raleigh Metropolitan Planning
Organization

February 2017

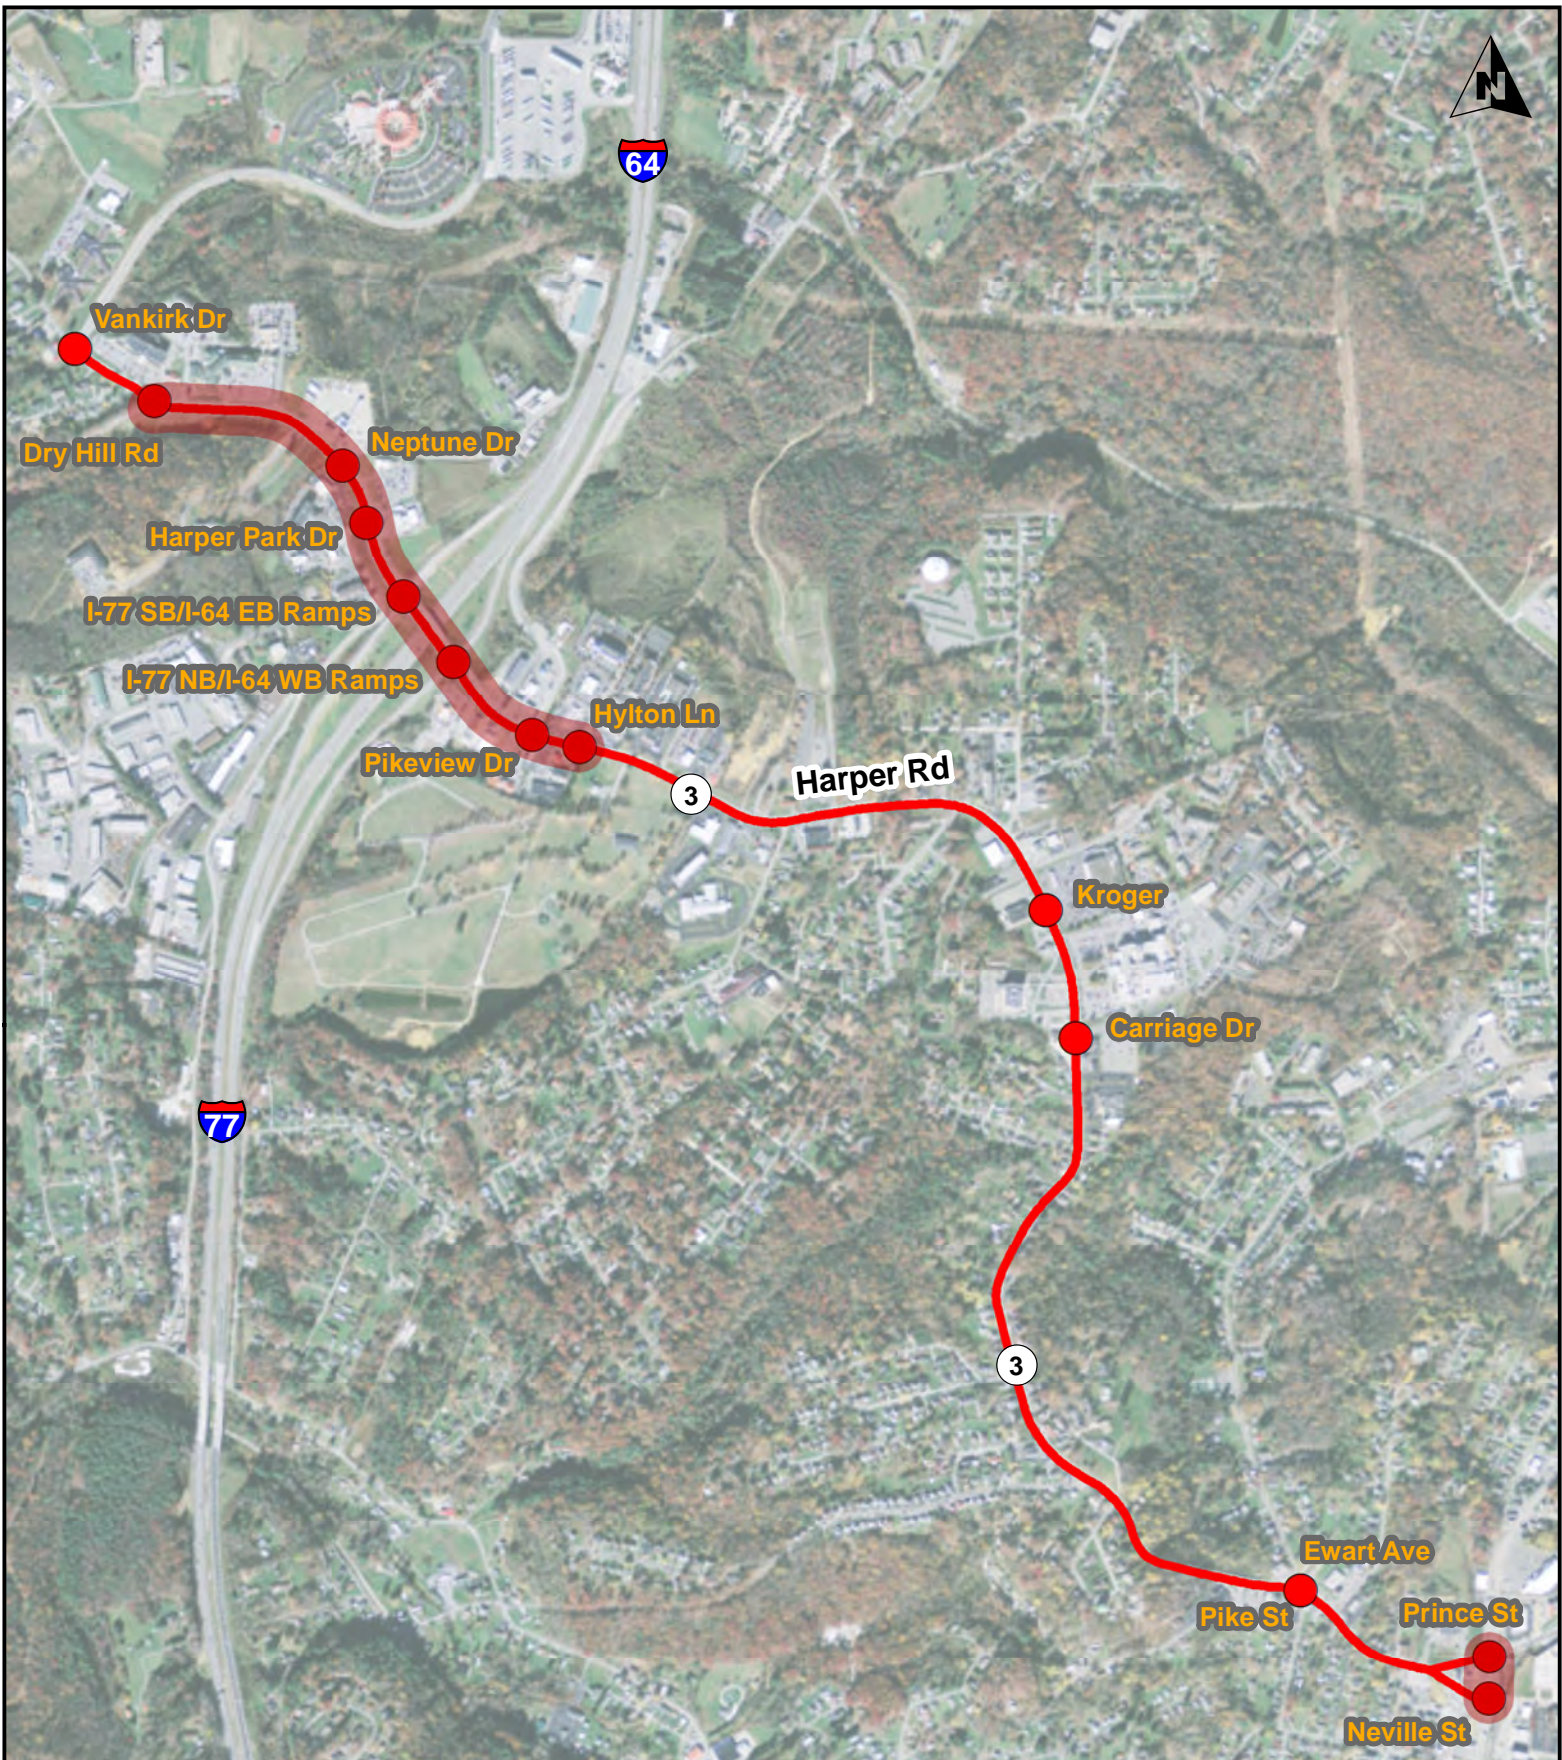
**Figure 6: Corridor 1
Signal System**

Existing signal timings were provided by WVDOH for signalized intersections that are part of a signal system. A signal system is defined as a group of traffic signals that are connected by communications hardware and software. **Figure 6**

through **Figure 8** illustrate the study intersections that are part of a signal system in Corridors 1 through 3. The intersections included in Corridor 4 are not part of any signal system. Signal timings are provided in **Appendix C**. It should be noted that even though signals are part of a system, the signal timings may not be coordinated/synchronized.

There are several signal systems within this study area. Intersections that are part a signal system are connected so that their individual controllers communicate with a single master controller. The master controller sets the global time for the signal system and communicates to the individual controllers when to change timing plans based on the time of day. Typically, controllers must be manufactured by the same company to be able to communicate with each other and the master controller. Exceptions are detailed above when the controller complies with various standards that make the communications possible.

Based on the field review and signal plans, it appears that all signal systems in this area are closed loop. This means that these intersections do not communicate to one central location, such as a Traffic Operations Center, and timings can only be modified by changing settings on the individual controller or the master controller in the field.

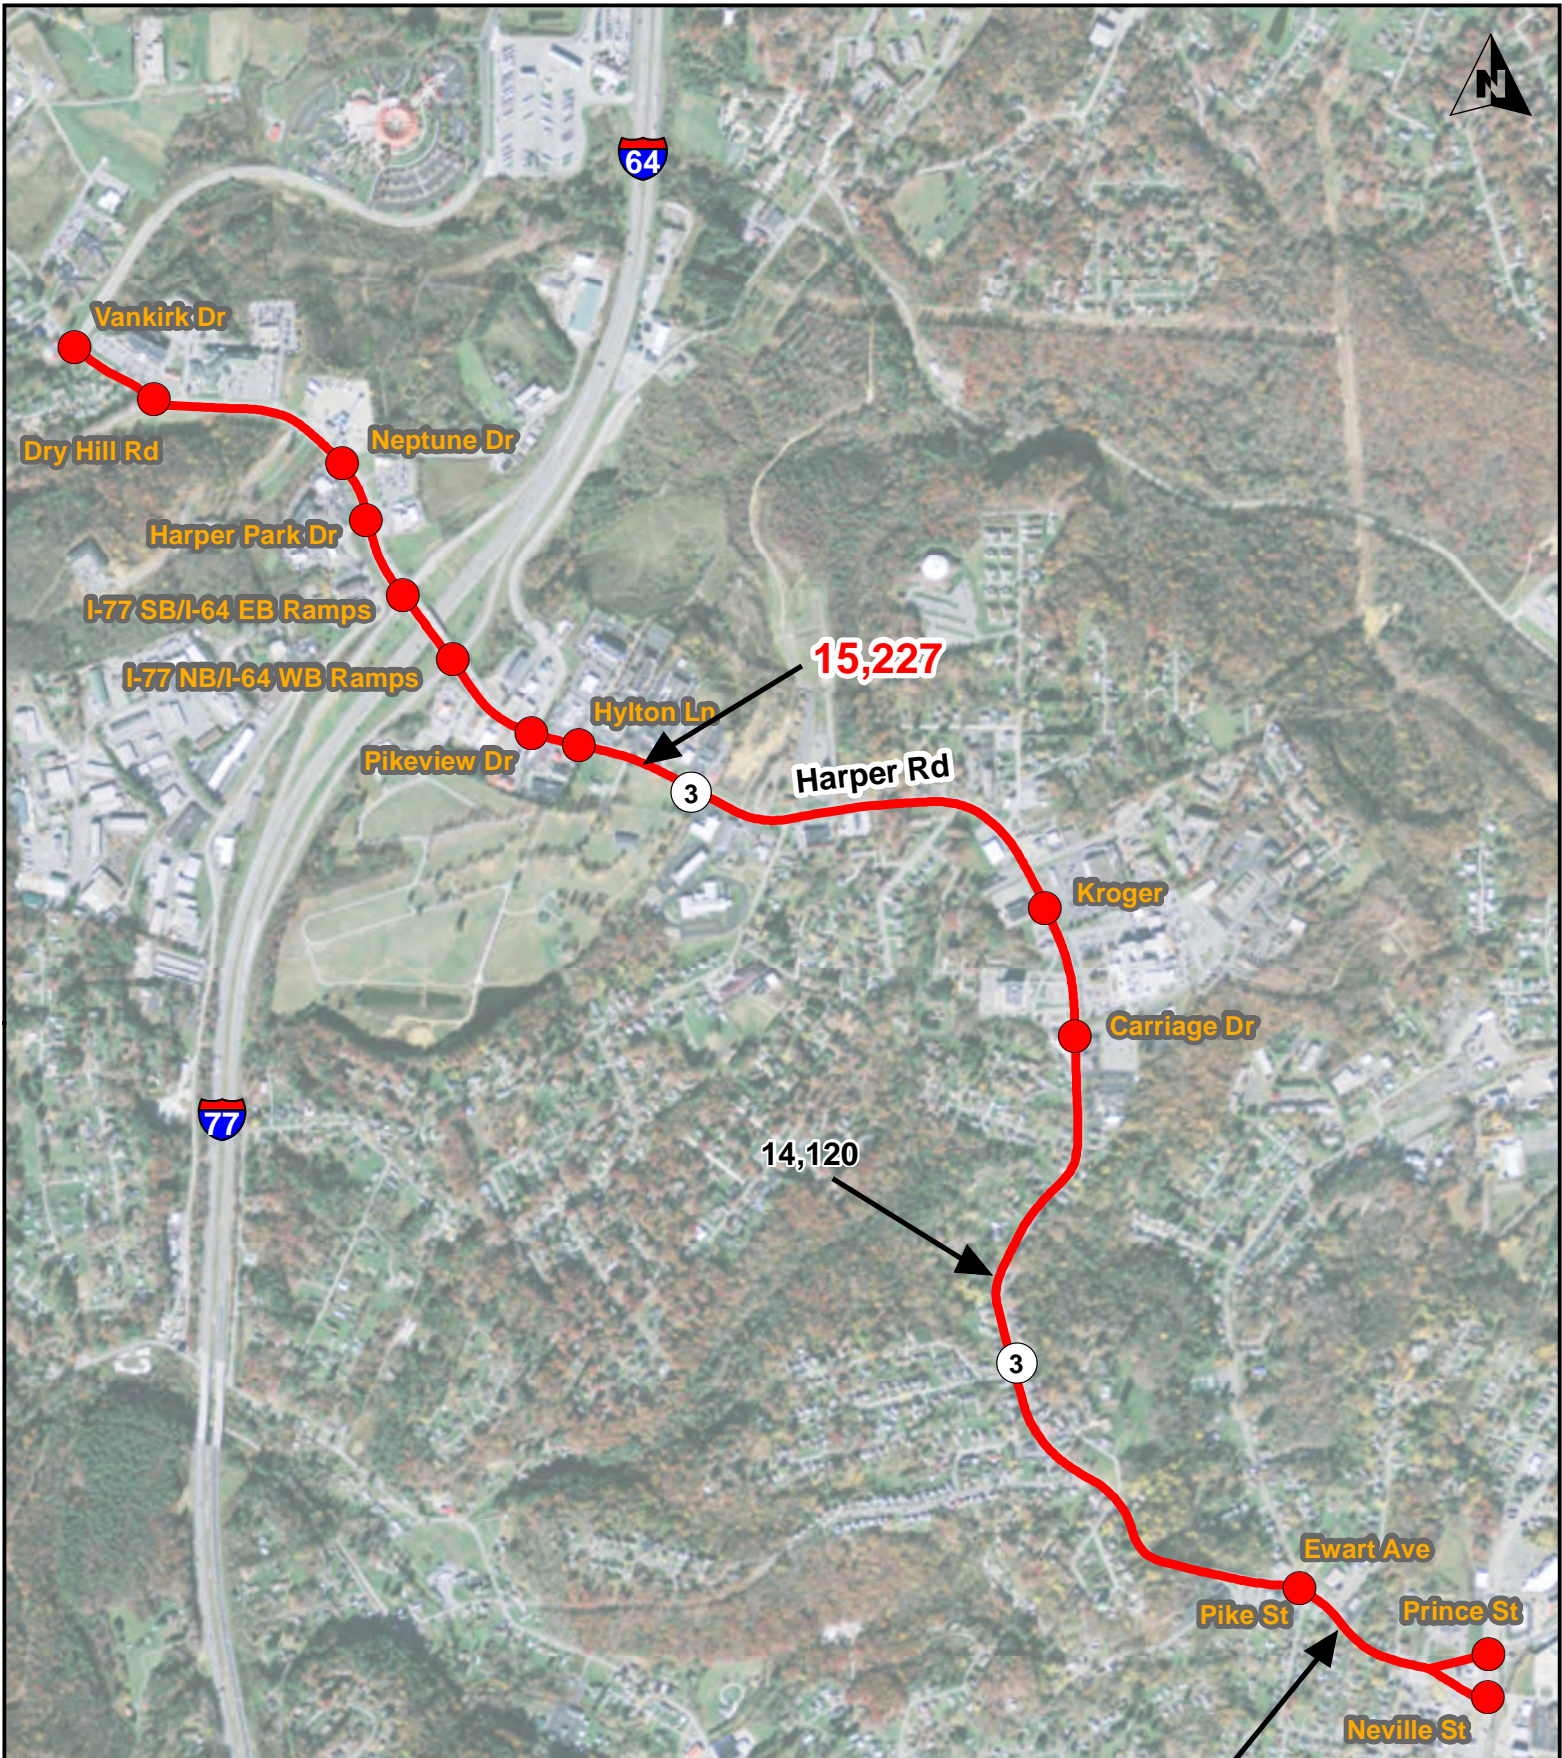
Figure 18: Corridor 1 ADT Volumes

Average daily traffic (ADT) volumes were obtained from the online West Virginia Traffic Counts database. While no turning movement counts were collected as part of this corridor prioritization review, the ADT volumes were beneficial in comparing relative traffic volumes between the corridors. **Figure 18** through **Figure 21** summarize the ADT for the four corridors. The highest traffic volumes in each corridor were as follows:

- Corridor 1: Near Hylton Lane – 15,200
- Corridor 2: Near Ragland Road – 25,500
- Corridor 3: Near Glenview Road – 25,500
- Corridor 4: Near Airport Road – 20,100

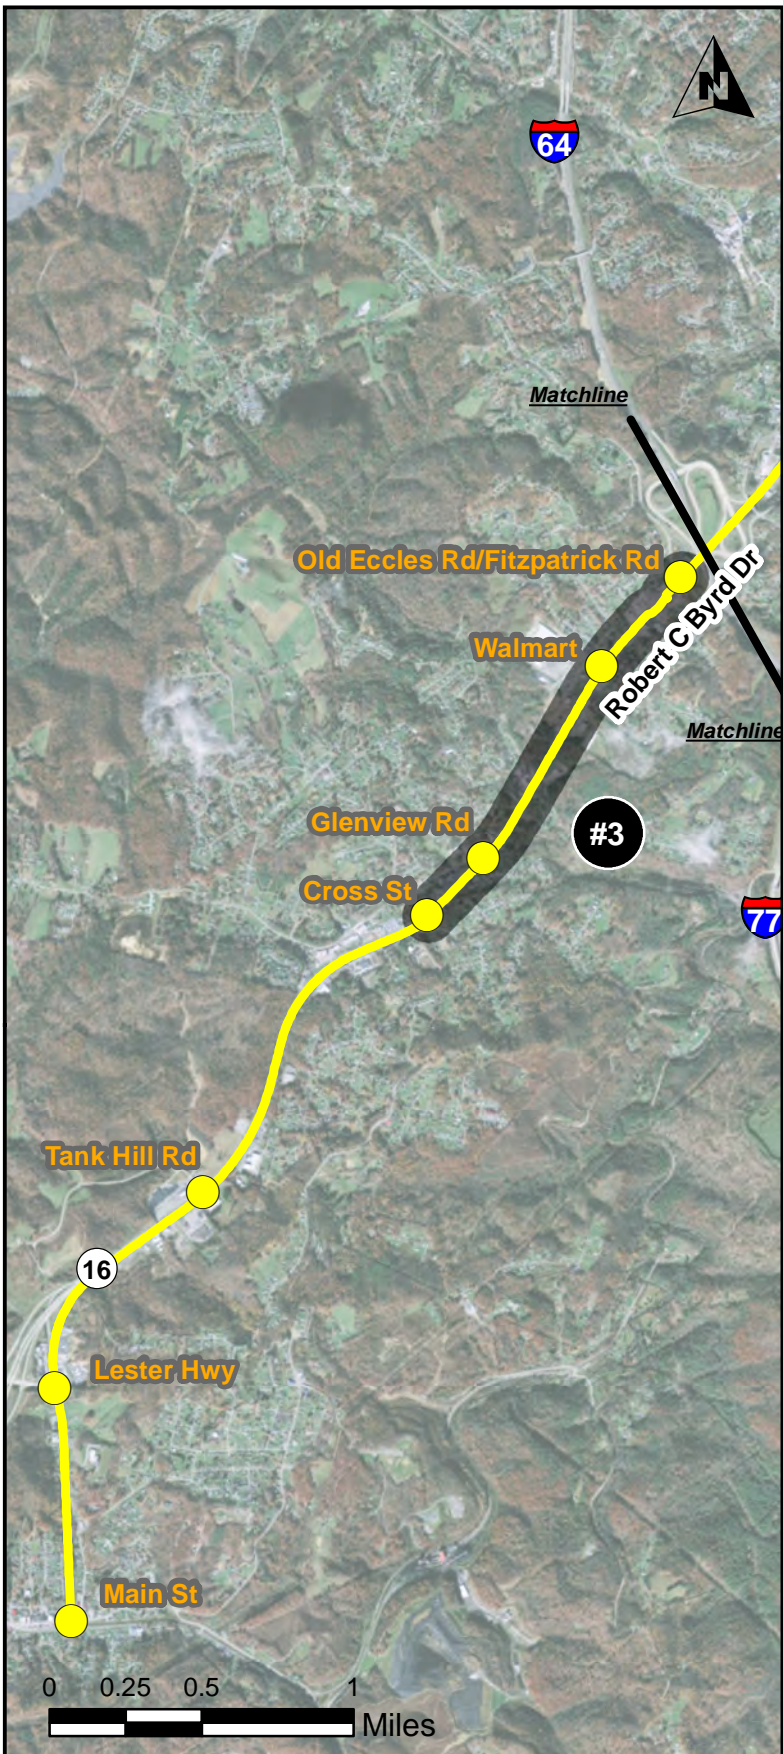
Figure 28: Corridor 3 Priorities

The existing conditions summaries and input from stakeholders were used to prioritize the corridors as illustrated in **Figure 26** through **Figure 29** and summarized below:

- Priority #2 – WV 16 from Maxwell Hill Road/Rural Acres Drive to Veterans Drive and WV 3 from Pike Street/Ewart Street to WV 16
 - More crashes occurred on WV 16 near Prince Street and Neville Street than along any other corridor segment analyzed as part of this prioritization study.

- Any improvement options proposed along WV 16 as part of the first corridor study for the intersections at US 19/Ragland Road, Market Road, and Templeview Drive/Beckley Crossing should be considered when studying this portion of WV 16.

- The intersection of WV 3 with Pike Street/Ewart Street was added to this corridor study segment because of its proximity to WV 16.
- Priority #3 – WV 16 from Old Eccles Road/Fitzpatrick Road to Cross Street

- Existing conditions analyses revealed that this segment had congestion and a relatively high crash frequency, including a fatality, compared to other corridor segments that were reviewed.

- Special consideration should be given to the new signal at Glenview Drive and signal progression in this segment of WV 16.
- Priority #4 – US 19 from WV 3/Fayette Street to C and O Dam Road
